## Anglesea River Fish Survey

Field Update – 21/07/2026

Assessment of water quality conditions and general fish surveys in the Anglesea River in response to a potential acidification event.

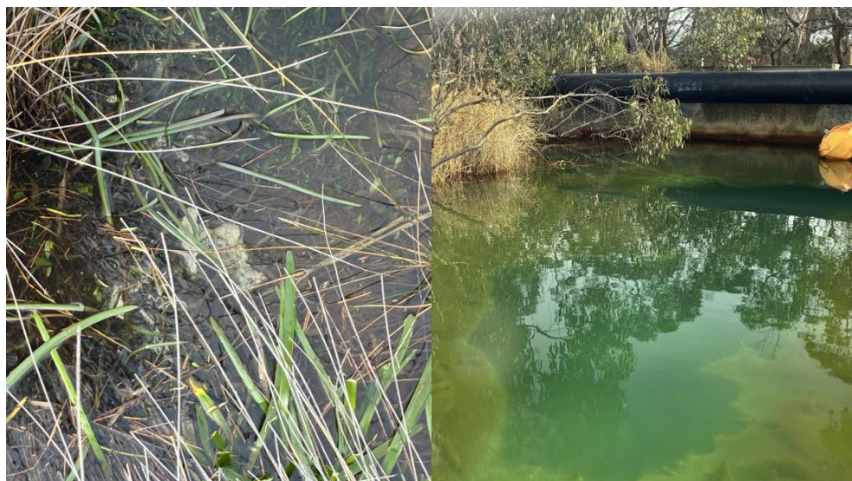
Several dead fish were observed at site 2 (figure 2), however they were in very advanced stages of decay and could not be discernibly identified to species level. It is likely these fish had been dead for several weeks or were possibly regurgitated by a bird.

Figure 2. Unidentified dead fish (left), Anglesea River at Coalmine Road (right)

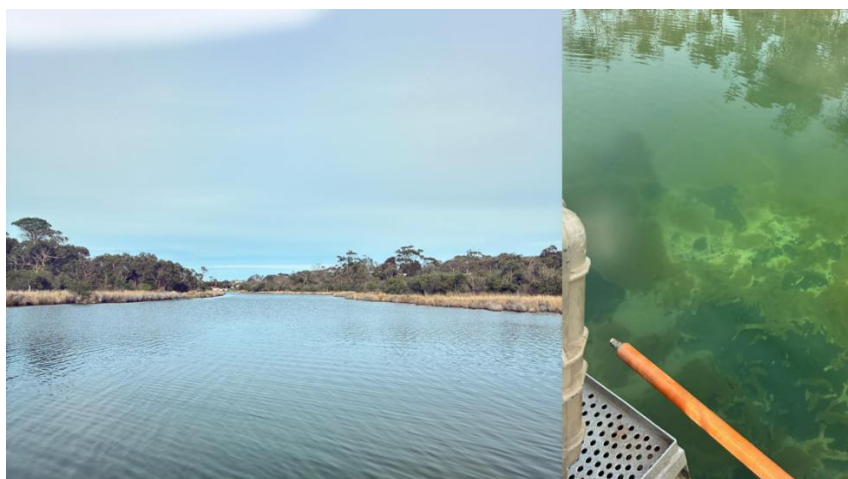
at all locations. The pH was lowest at site 4, approximately the middle of the estuarine section surveyed. A turquoise colouration of water was observed at several locations.

Figure 3. Anglesea River at site 2 (left), turquoise colouration in riverbed at site 1 (right)

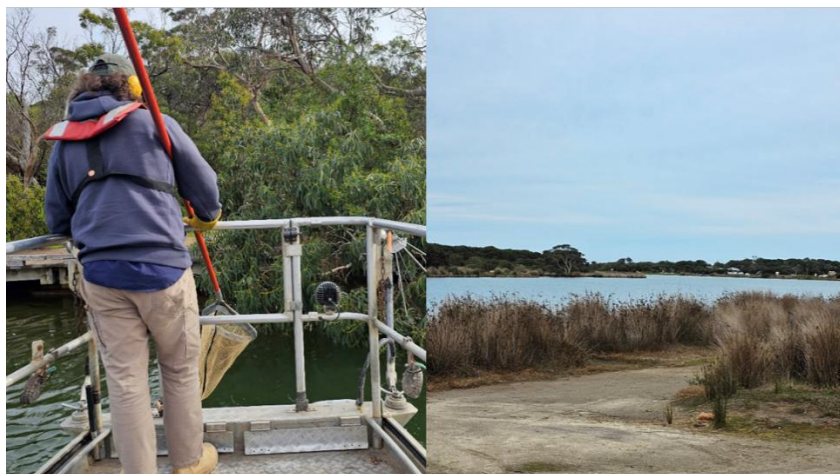
Figure 4. Boat electrofishing at site 1 (left), Anglesea River estuary near the Anglesea visitor information centre (right).
